STRESS CORROSION CRACKING OF ROCK BOLTS

Erwin Gamboa

A THESIS SUBMITTED TO THE UNIVERSITY OF QUEENSLAND
FOR THE DEGREE OF DOCTOR OF PHILOSOPHY

NOVEMBER 2004

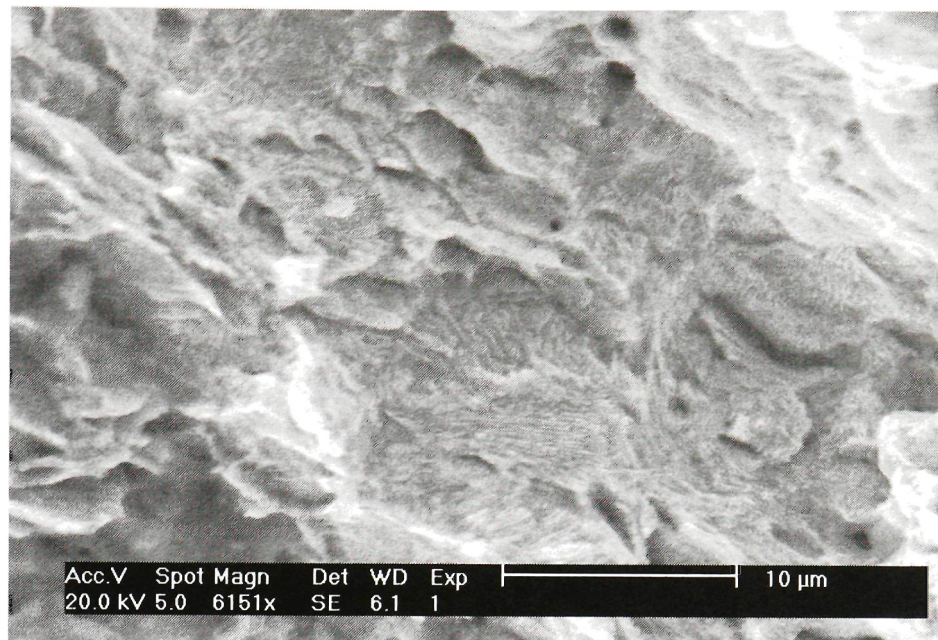
FIGURE 5.40: Higher magnification shot of Figure 5.39

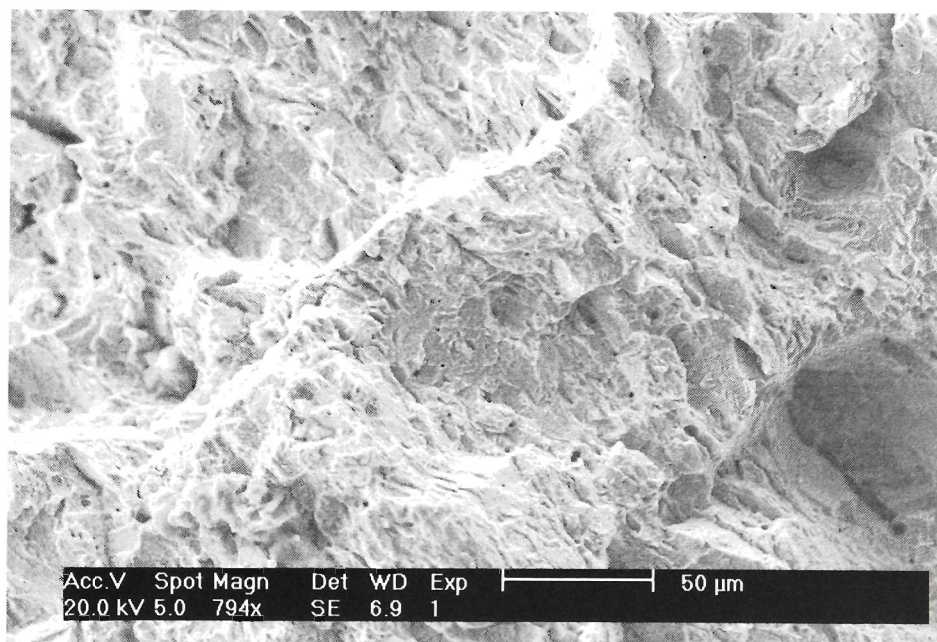
FIGURE 5.41: SCC region x794

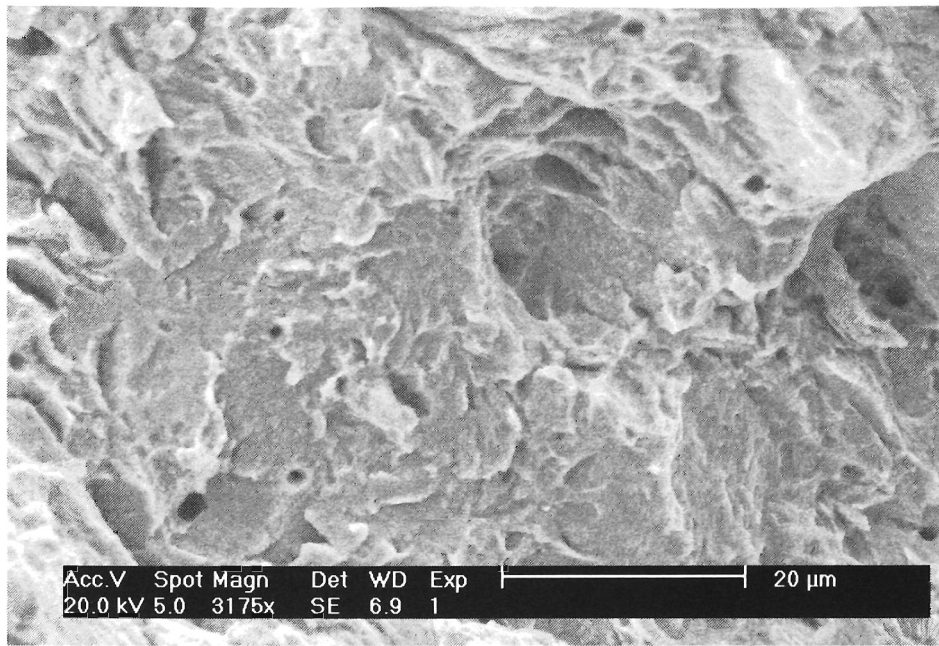
FIGURE 5.42: Detail of Figure 5.41 x3175

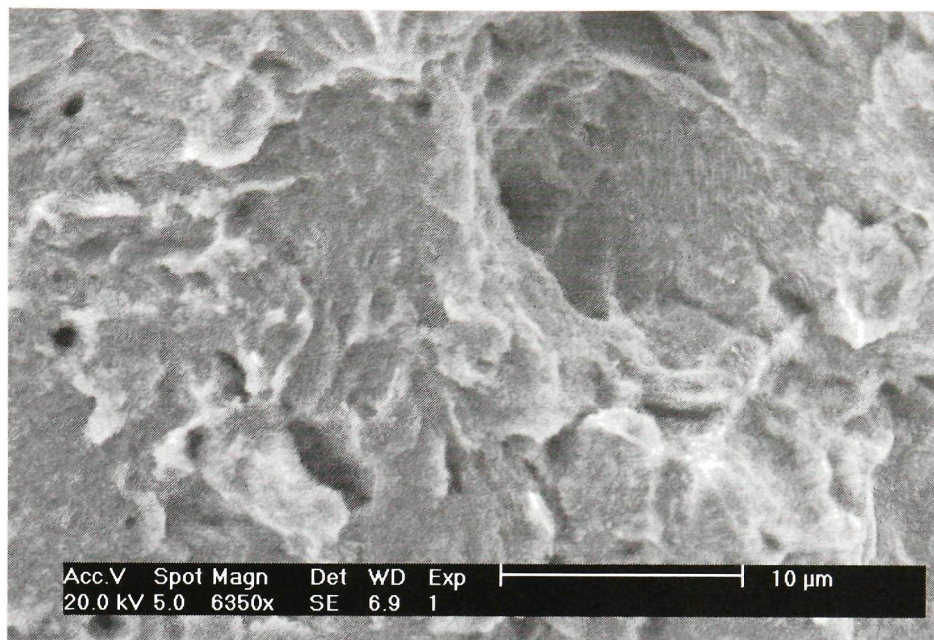
FIGURE 5.43: Detail of Figure 5.41 x6350

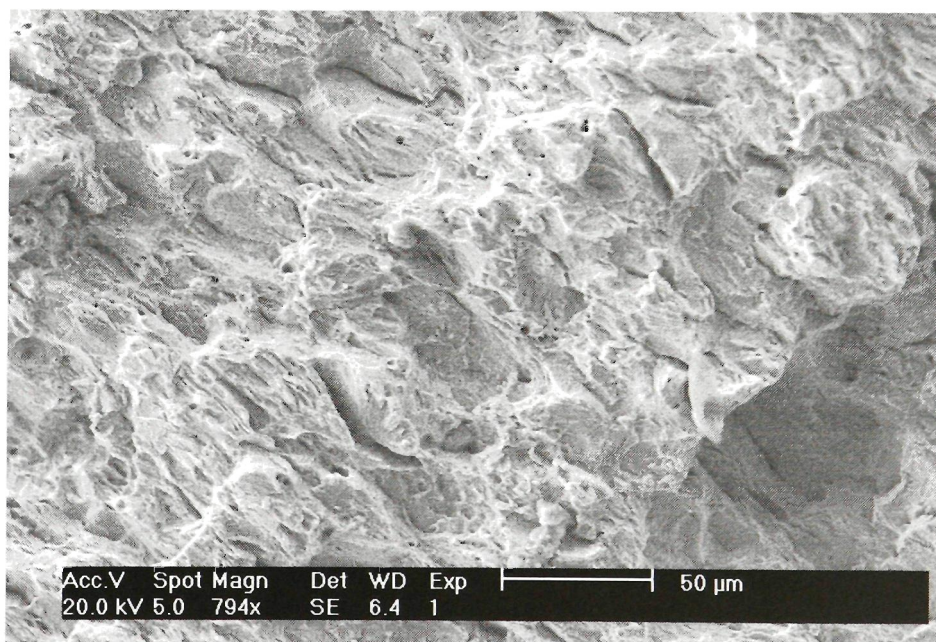
FIGURE 5.44: SCC region x794

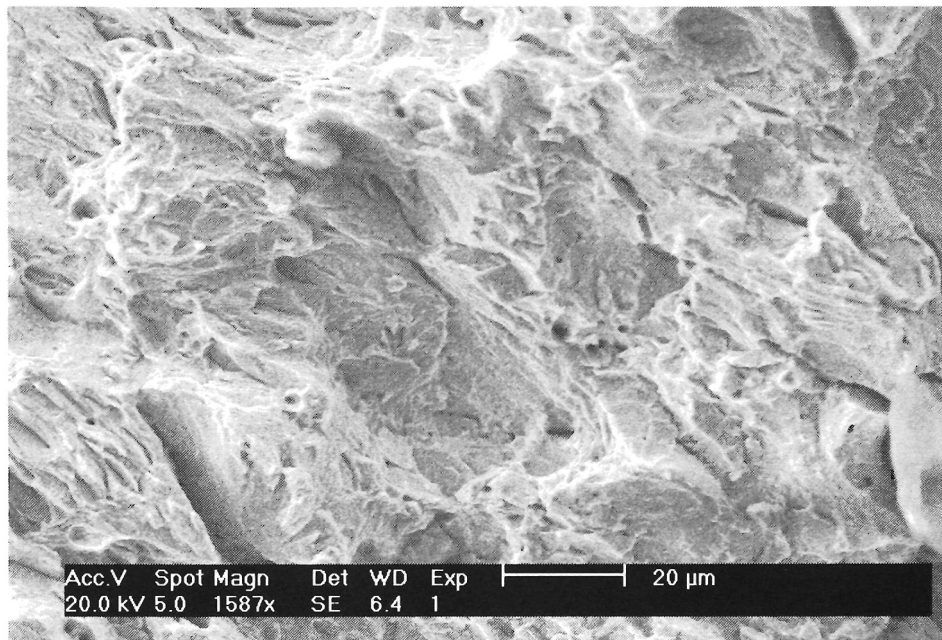
FIGURE 5.45: Detail of Figure 5.44 x1587

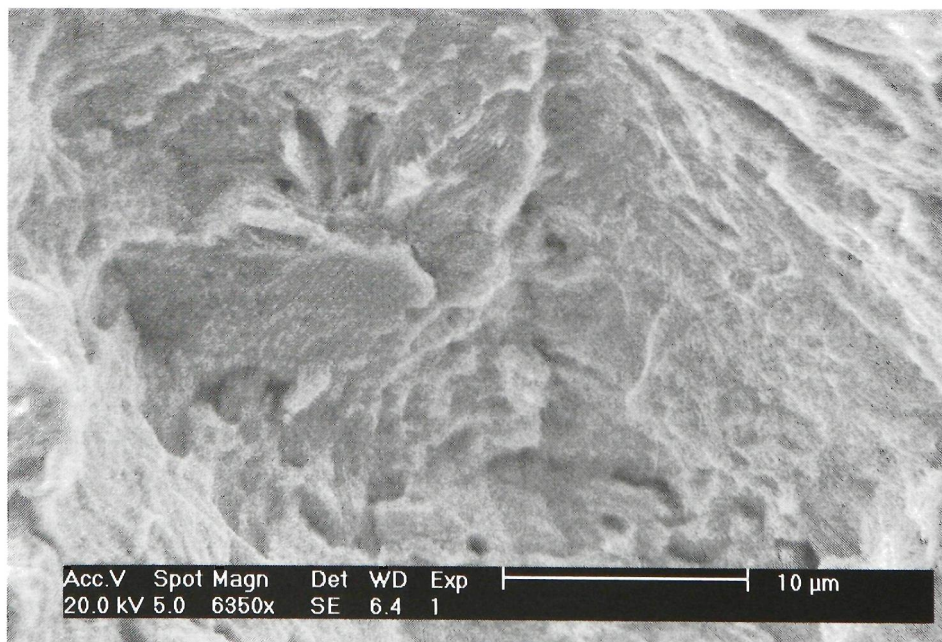
FIGURE 5.46: Detail of Figure 5.44 x6350

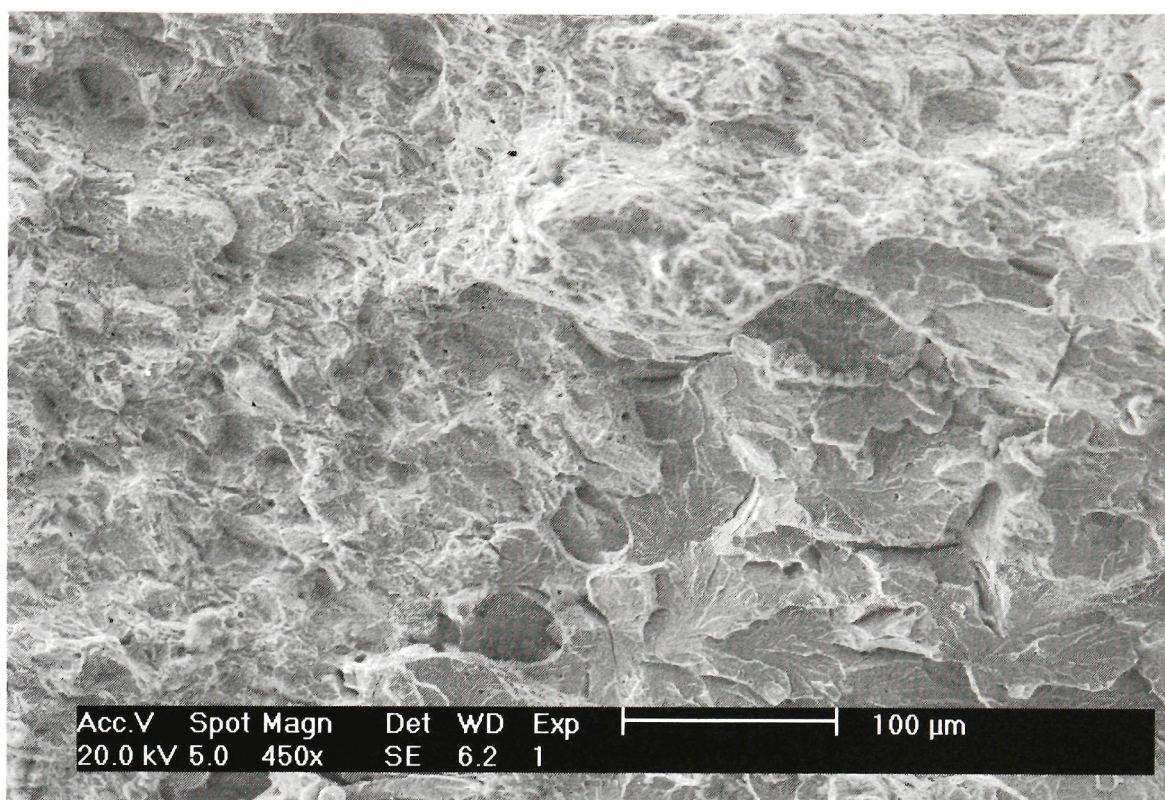
FIGURE 5.47: SCC-FFS interface x450

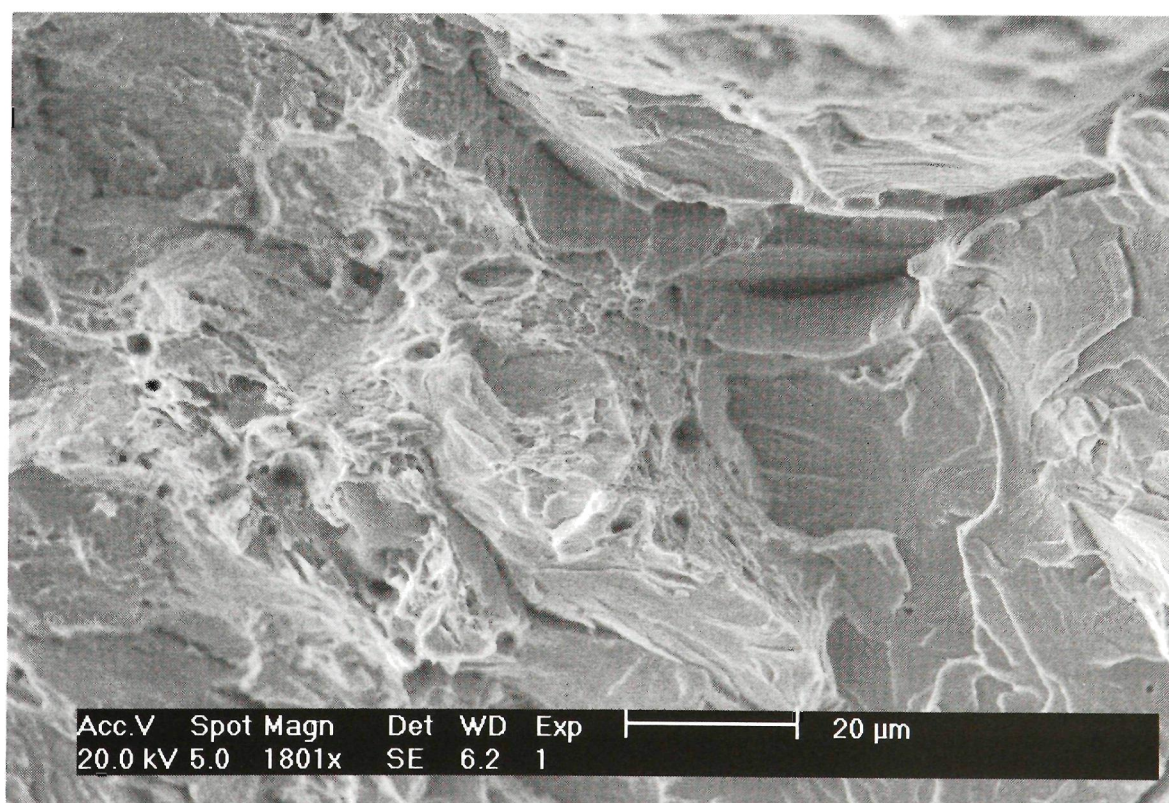
FIGURE 5.48: SCC-FFS interface x1801

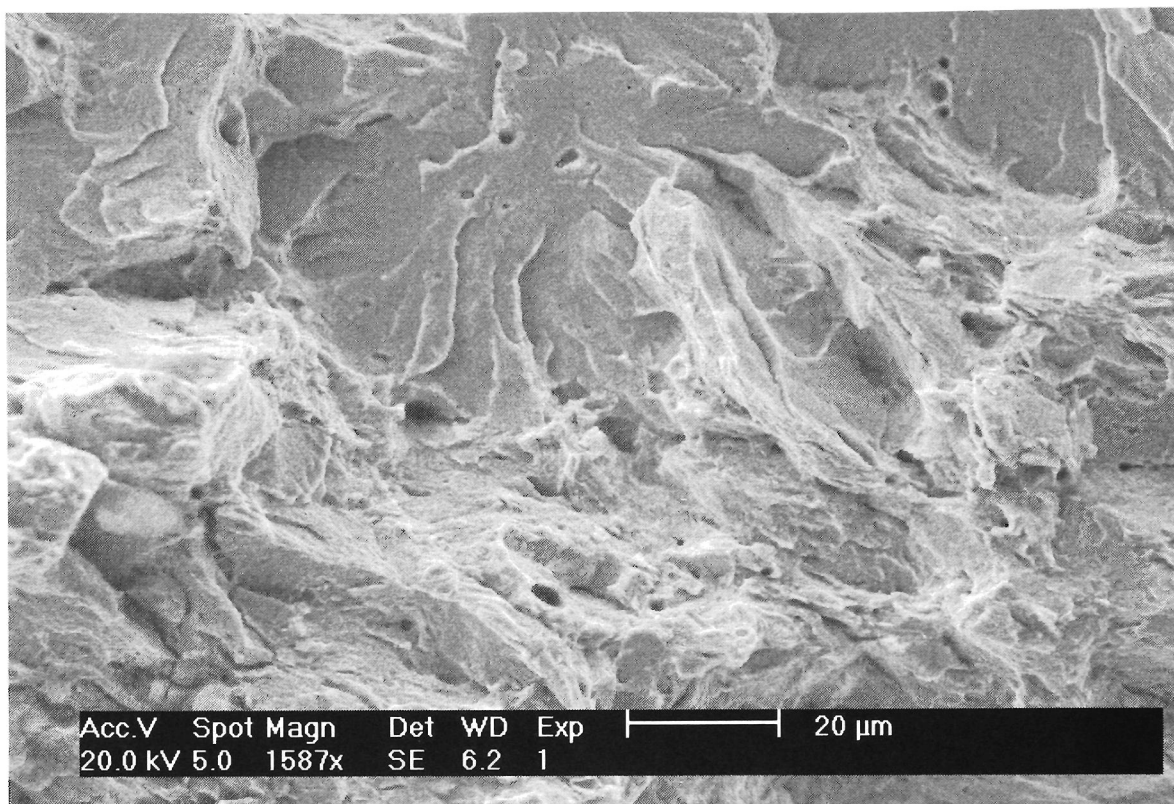
FIGURE 5.49: SCC-FFS interface x1587

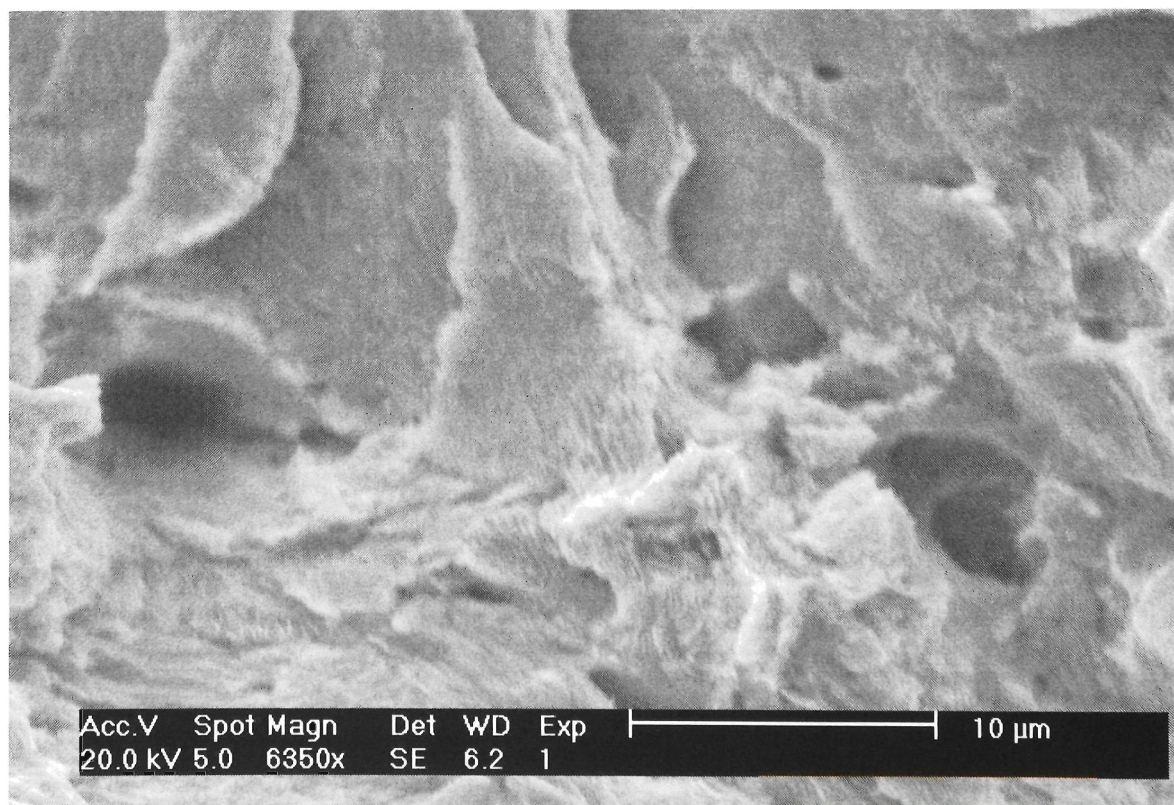
FIGURE 5.50: SCC-FFS interface x6350

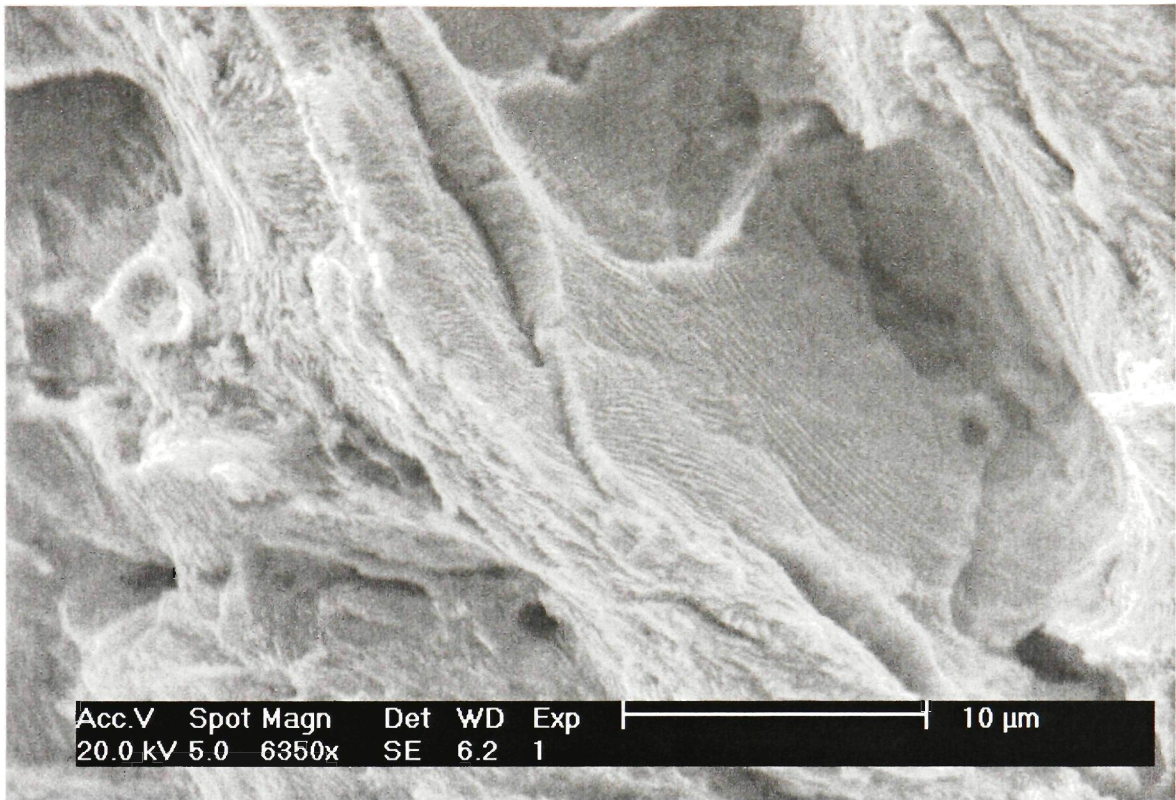
FIGURE 5.51: SCC-FFS interface x6350

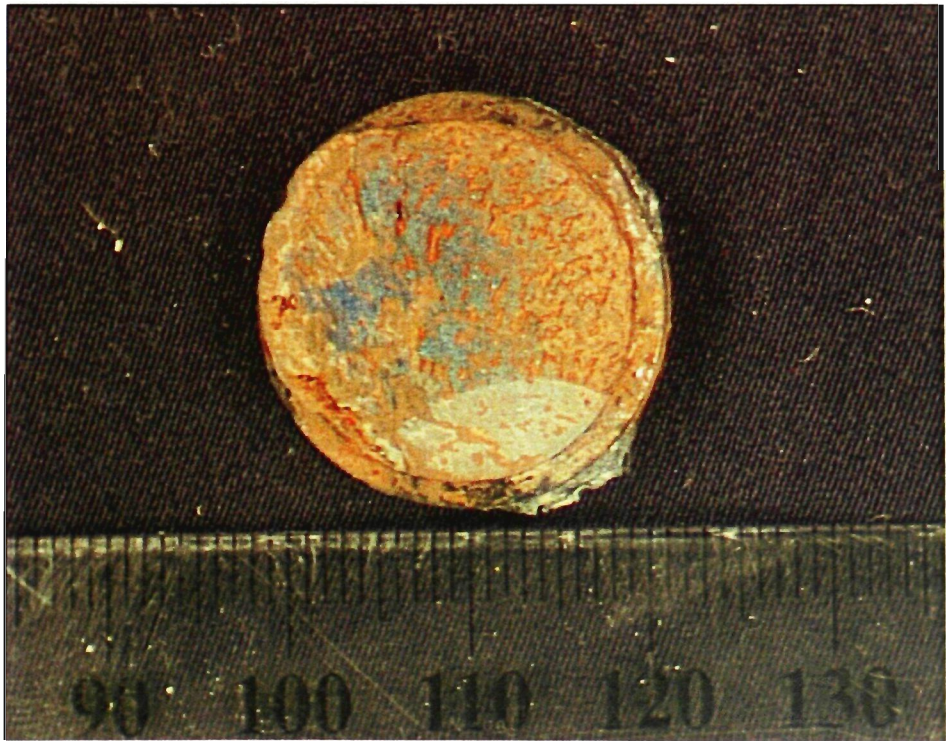
FIGURE 5.52: Rock bolt fracture surface overview

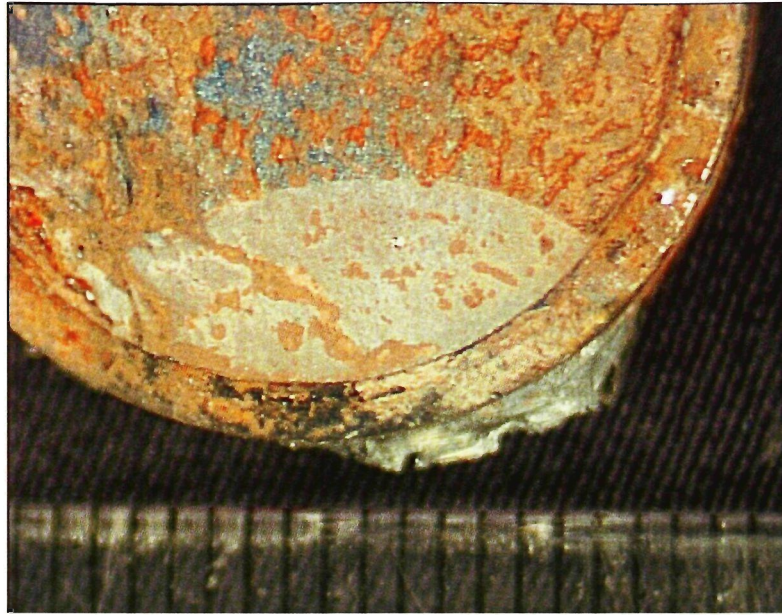
FIGURE 5.53: Rock bolt thumbnail area overview

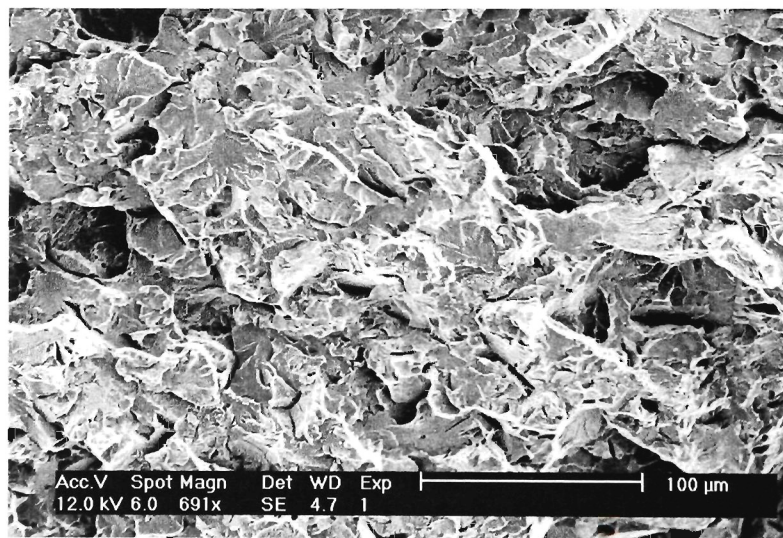
FIGURE 5.54: Rock bolt Fast Fracture Surface

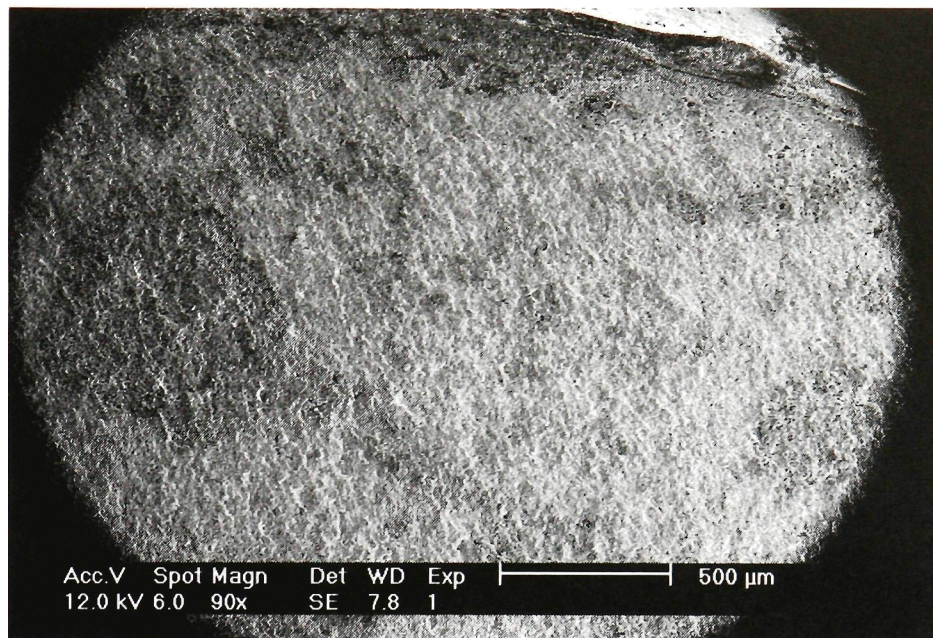
FIGURE 5.55: Overview of thumbnail region

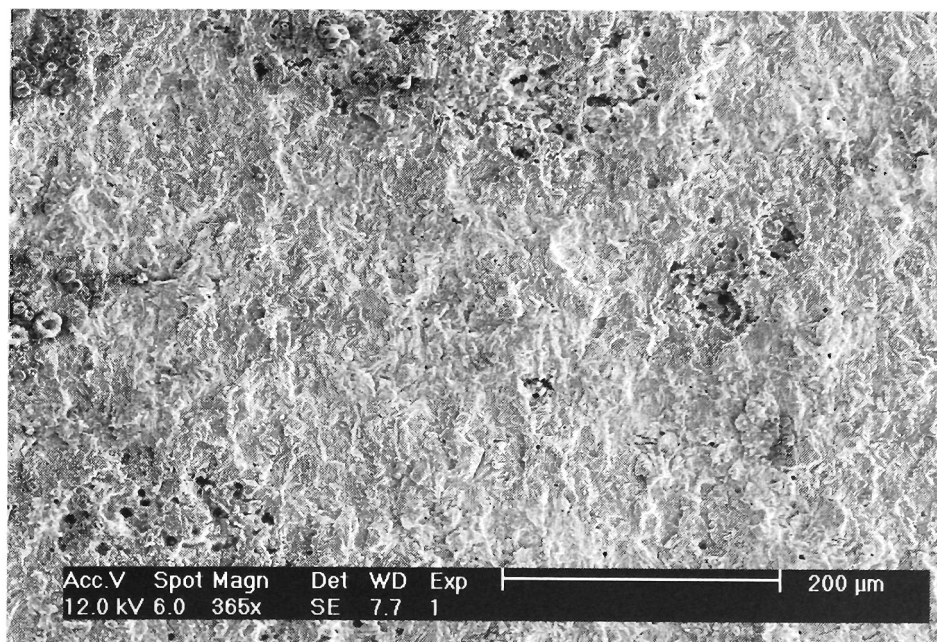
FIGURE 5.56: Subcritical crack growth region

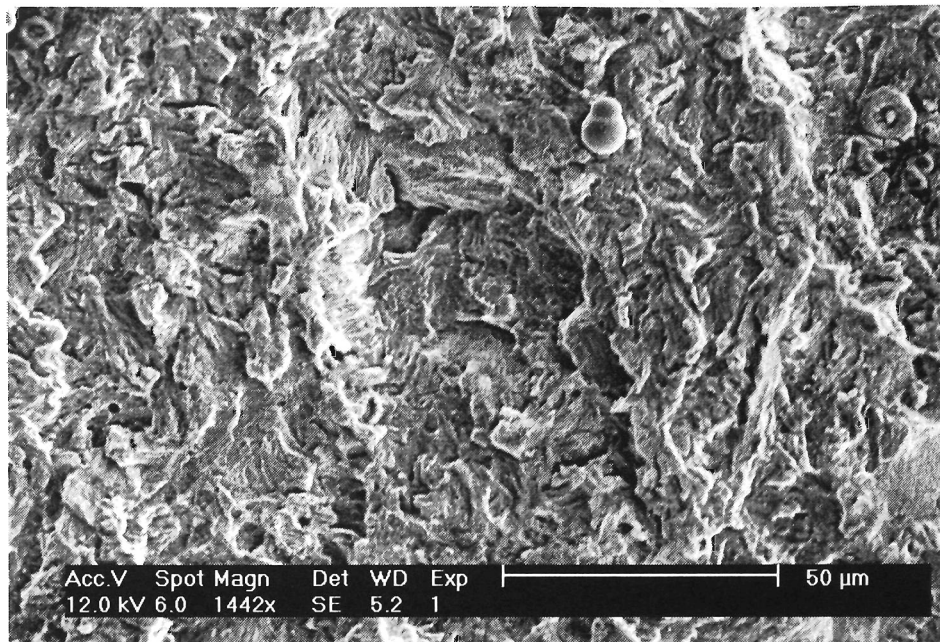
FIGURE 5.57: High magnitude view of subcritical crack growth region

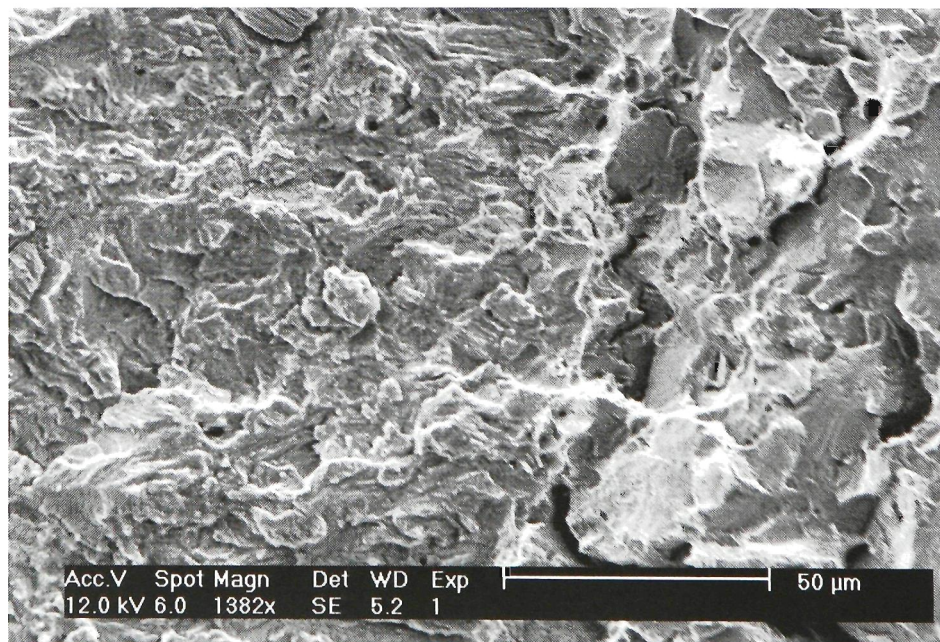
FIGURE 5.58: Interface between subcritical crack growth and FFS

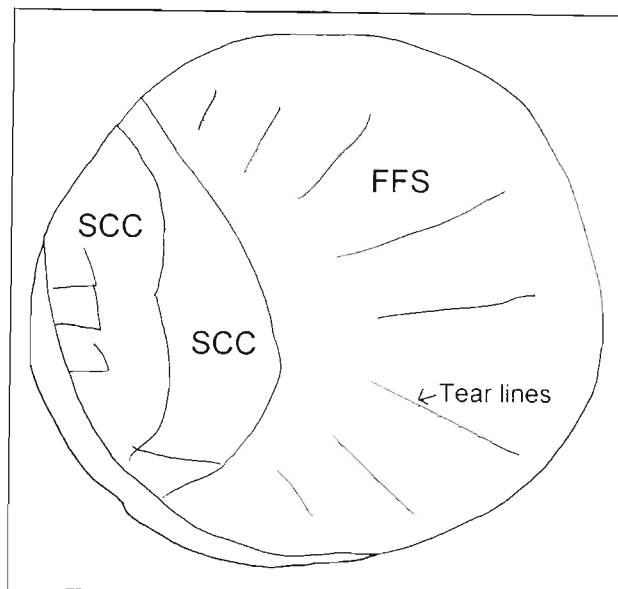
Figure 5.59 shows the fracture surface of the rock bolt. The bolt was received with its fracture surface damaged in several areas. Most damage occurred in the subcritical crack growth region, the thumbnail shaped area. The fast brittle fracture region was relatively intact, with little corrosion products on its surface.

(b) Schematic view showing SCC, tear lines and fast fracture areas

FIGURE 5.59: Rock Bolt fracture surface

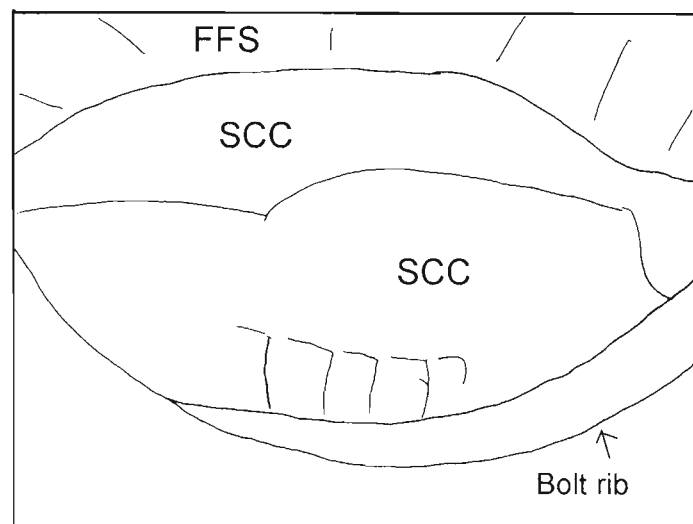
A higher magnification view is presented in Figure 5.60. This rock bolt displayed features that indicated that SCC was responsible for the failure of this bolt. A thumbnail shaped SCC area was present, with fast fracture tear lines radiating from that area outwards. This thumbnail area was 8 mm deep and its length was 15 mm long. From these measurements, the estimated total SCC area in the bolt was approximately 60 mm². Compared to the bolt area of approximately 363 mm², the thumbnail area covered 16.7% of the total bolt area. This value was much larger than previous values measured from other bolts of approximately 1.9%.

(b) Schematic view showing SCC and fast fracture areas

FIGURE 5.60: Rock bolt SCC overview

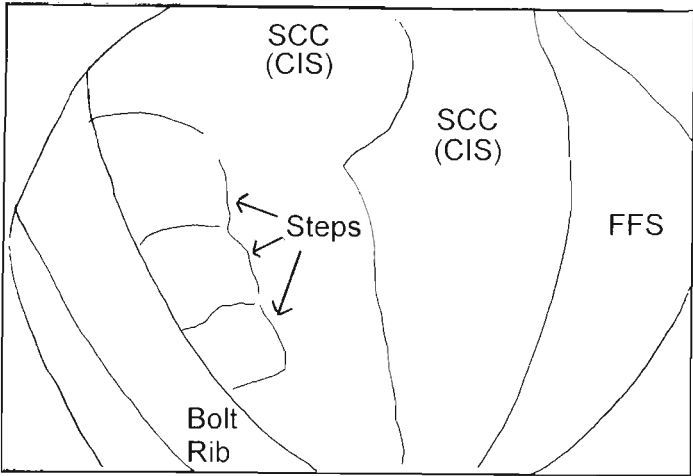
Figure 5.61 shows an overview of the SCC region. This shows a thumb nailed SCC region and a fast fracture surface (FFS) region as shown schematically. As the bolt was cracking, the SCC region grew until it reached a critical size, after which the bolt failed by fast brittle failure. This almost instantaneous event produced the tear lines that radiate from the SCC area.

(b) Schematic view showing bolt rib, SCC and fast fracture areas

FIGURE 5.61: Rock Bolt SCC overview

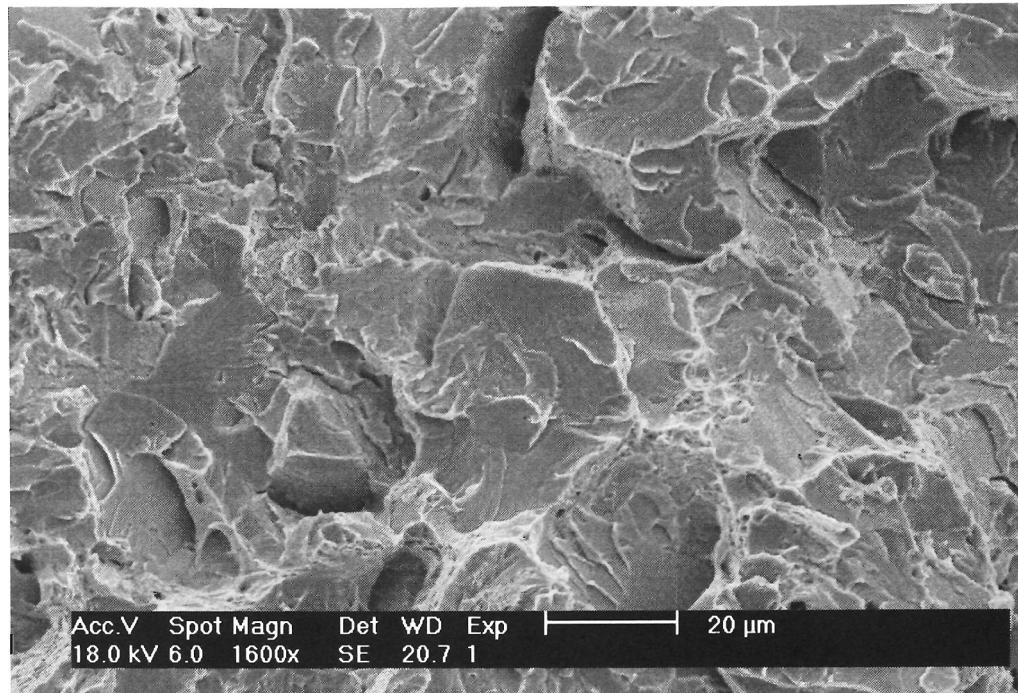
Figure 5.62 shows the typical brittle fracture surface in the overload region. The surface tearing resembled maple leaves, growing in the direction of the final crack propagation. The same fast fracture pattern has been found in other analysed rock bolts as well as LIST samples. This fracture surface covered about 83% of the fracture surface.

FIGURE 5.62: Typical Fast Fracture Surface (FFS)

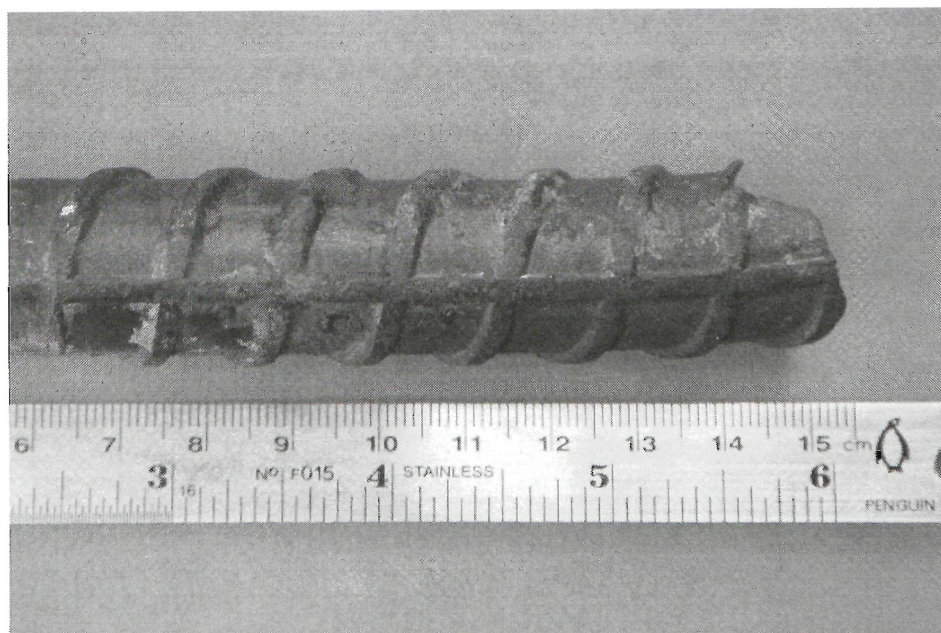
Figure 5.67 presents the rock bolt from the side. The area just below the fracture was clearly bent, suggesting shearing in the rock strata.

FIGURE 5.67: Macroscopic view of colliery Q rock bolt. The fracture was at the right end of the bolt segment.

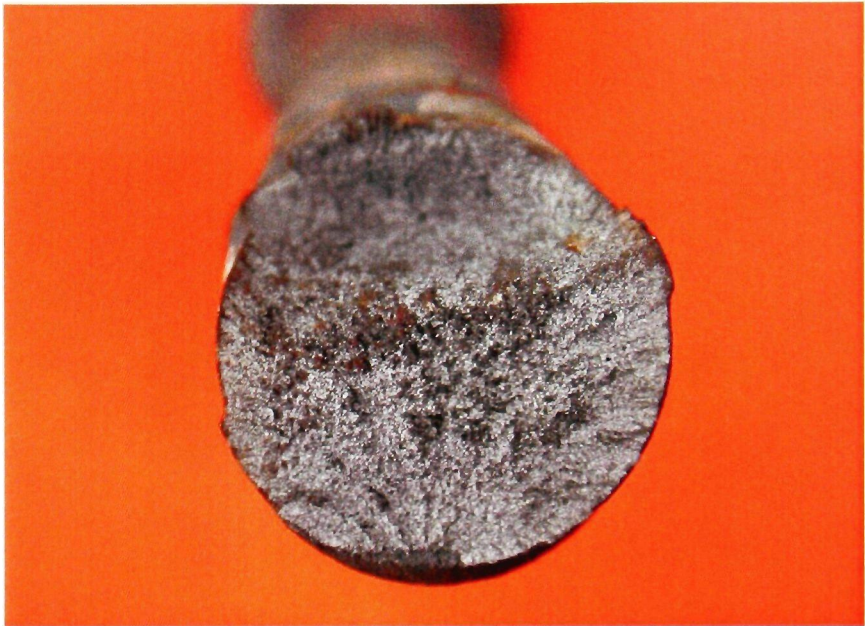
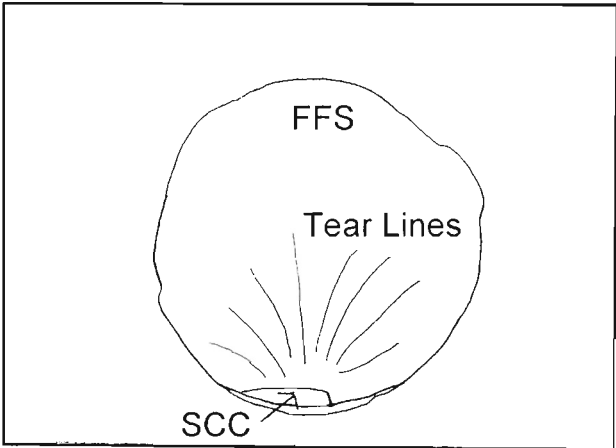
Figure 5.68 shows the fracture surface. The fracture surface was relatively intact, with little corrosion products on its surface. Away from the thumbnail region, on the opposite side of the bolt, there was a depression. This depression was caused by the path that the fast brittle crack followed. This crack path has been observed in previous bolts. The fracture surface of this region was the was as found in the Fast Fracture Surface (FFS).

(a) Macroscopic view of the bolt's fracture surface

(b) Schematic view showing SCC, tear lines and fast fracture areas

FIGURE 5.68: Rock Bolt fracture surface

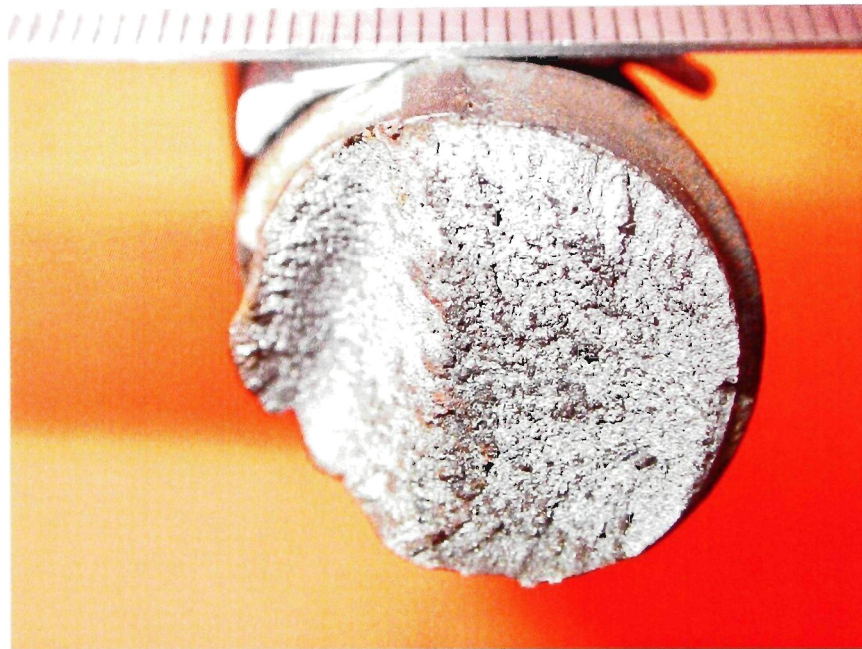
Another similarity between this bolt and ones previously studied was that the SCC initiated at the foot of a rib. No bolt examined to date had shown an initiation site apart from at the foot of a rib. Figure 5.69 shows the dark thumbnail region originating on the bolt rib.

FIGURE 5.69: Macroscopic view of colliery Q rock bolt. The SCC initiation site was at the foot of the bolt rib.

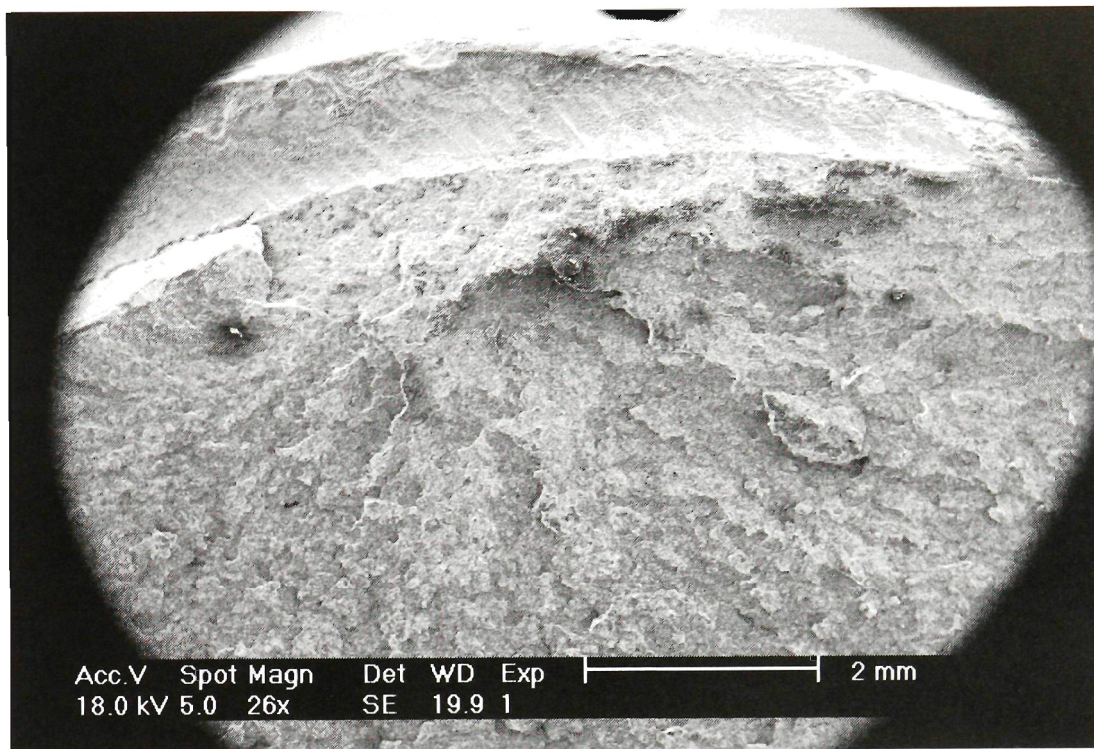
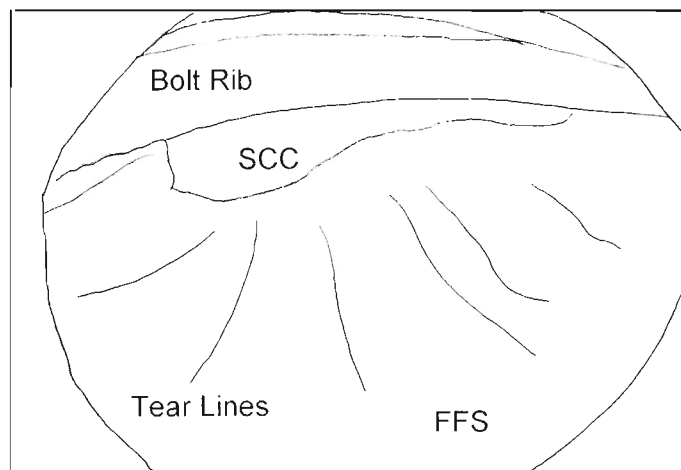
Figure 5.70 shows an overview of the SCC region. This shows a thumb nailed SCC region and a fast fracture surface (FFS) region as shown schematically. As the bolt was cracking, the SCC region grew until it reached a critical size, after which the bolt failed by fast brittle failure. This almost instantaneous event produced the tear lines that radiate from the SCC area.

(a) Overview of the bolt's SCC area

(b) Schematic view showing SCC, tear lines and fast fracture areas

FIGURE 5.70: Rock bolt SCC overview

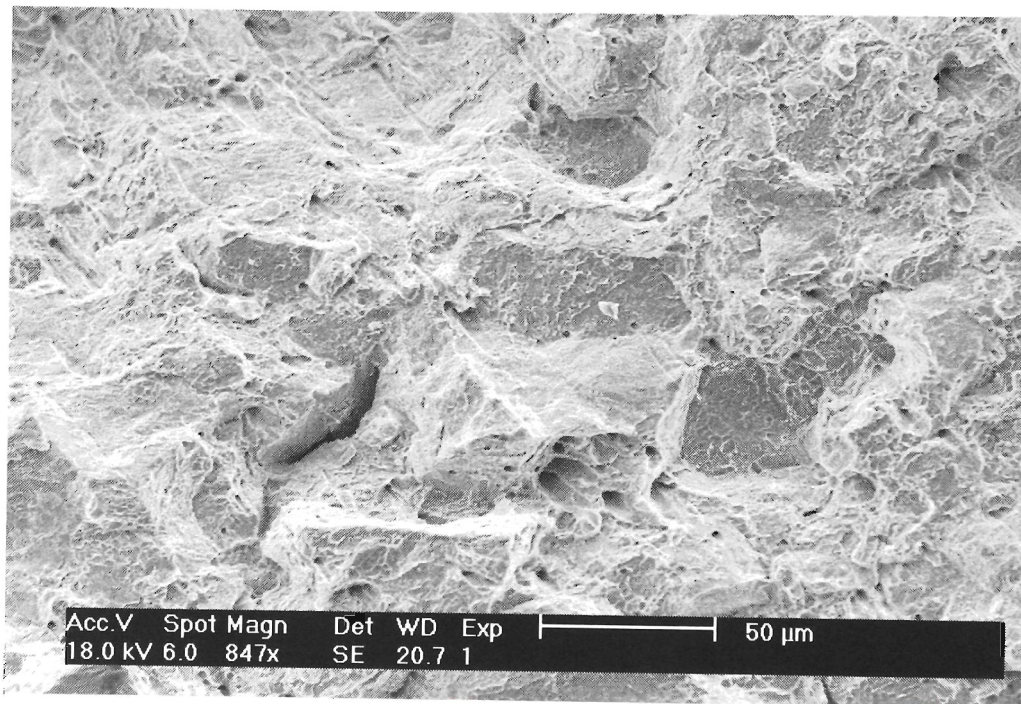
Figure 5.71 was taken from within the thumbnail shaped area close to the FFS. The Figure shows a typical Corrugated Irregular Surface (CIS) similar to other such surfaces which have been found in other rock bolts failed by SCC. Figure 5.22 shows a typical CIS surface in a different rock bolt. By comparing these Figures it can be seen that both bolts showed irregular surfaces. Both display the typical features of CIS (a network of branched porous channels on flat corrugated regions joined by steep corrugated slopes).

FIGURE 5.71: Typical SCC (CIS) topography

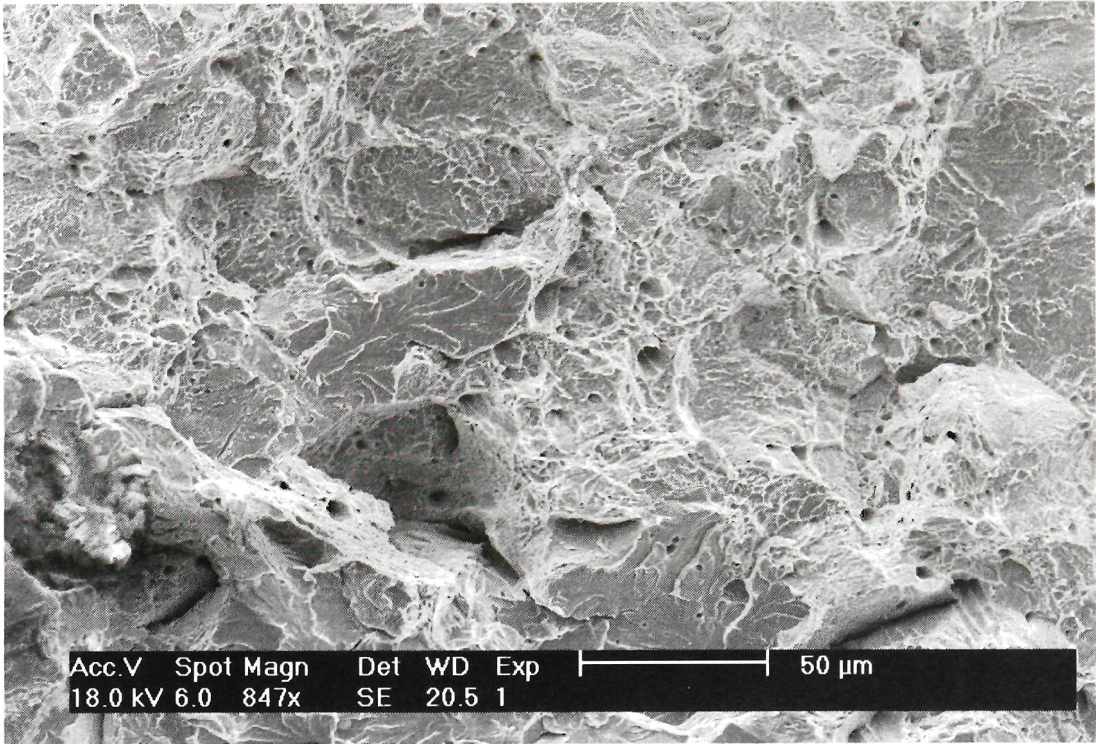
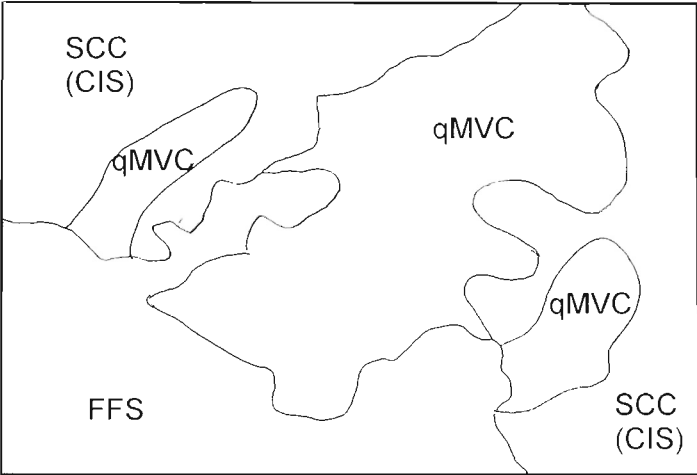
Figure 5.72 shows the slow crack growth region on the top and the FFS on the bottom. Both regions were separated by patches of quasi Micro Void Coalescence (qMVC). It is suggested that qMVC was formed when hydrogen had penetrated ahead of the crack tip. If hydrogen was not present in the material, the fracture of the interface at that point would resemble that of Micro Void Coalescence (MVC) observed in pure ductile failures, but with the presence of hydrogen there was qMVC. It is worthy to note that the overload region was brittle cleavage, as the crack was larger than the critical crack size of the fracture criterion. The appearance of the interface region between the CIS region of the subcritical crack growth and the overload was interpreted as being influenced by the amount of hydrogen diffused ahead of the crack tip. Typical features of qMVC was the porous surface and small microvoids in relatively flat regions, extending “fingers” into the FFS.

(a) CIS and FFS regions separated by qMVC “fingers”

(b) Schematic view showing SCC, qMVC and FFS regions

FIGURE 5.72: SCC (CIS) - FFS interface

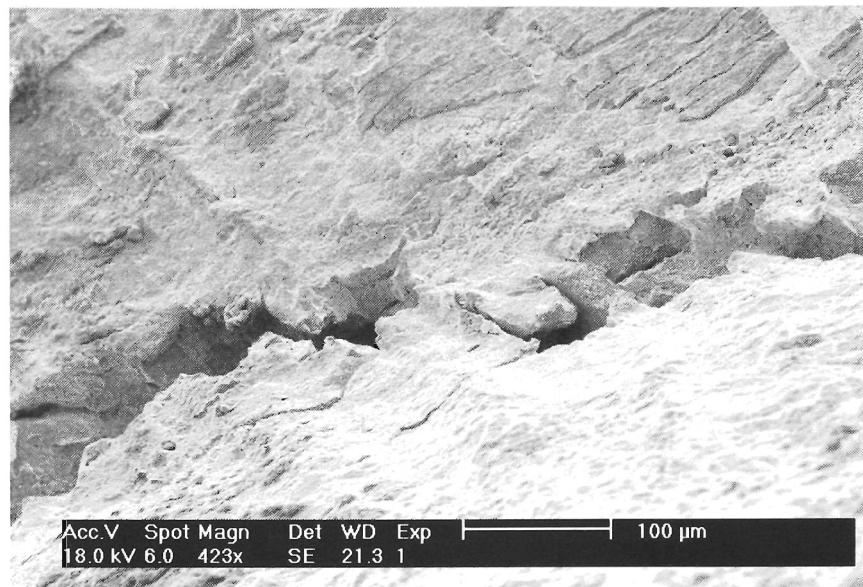
Figures 5.73 - 5.75 show the crack running along the bolt rib. The secondary cracks grew on the rib and the fracture surface of these cracks (CIS) was the same as that seen on the main fracture surface. Figure 5.75 shows the fracture surface at a higher magnification.

FIGURE 5.73: SCC crack running along the bolt rib

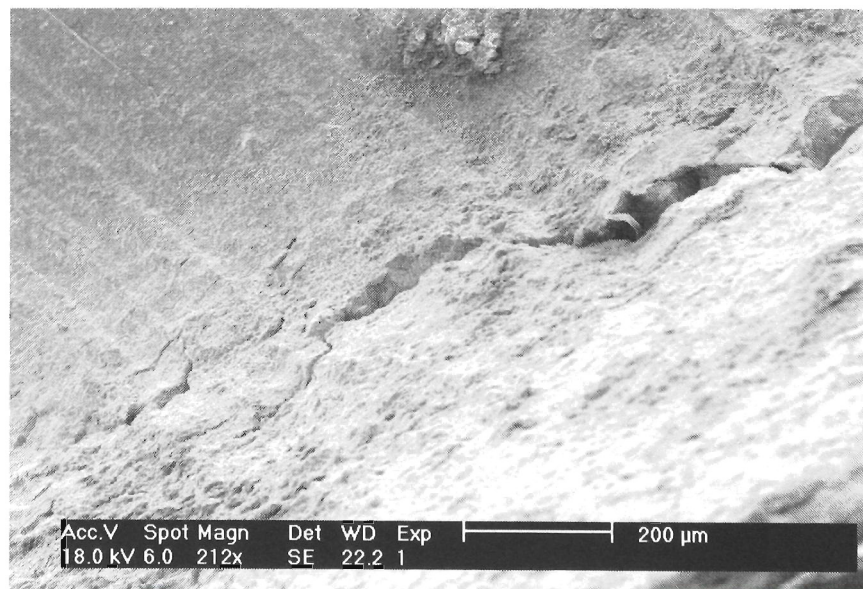
FIGURE 5.74: Beginning of SCC crack running along the bolt rib

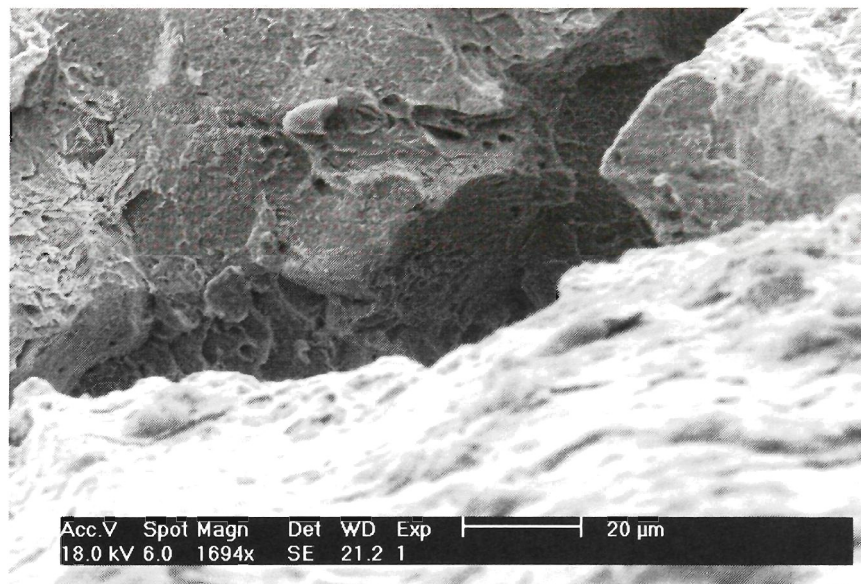
FIGURE 5.75: CIS topography running inside the SCC crack along the bolt rib
